The Longo

Response

The Incident

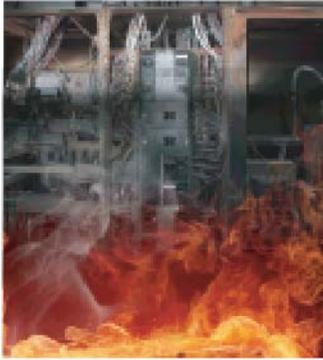
Remnants of the transformer that ruptured and sent burning oil into the switchgear area.
