## LOWER MANHATTAN

# WALL STREET

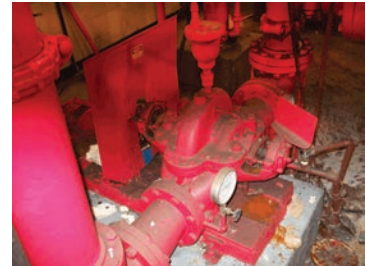
*75 HP pump that needed overhaul and went to our Wharton Servicenter.*

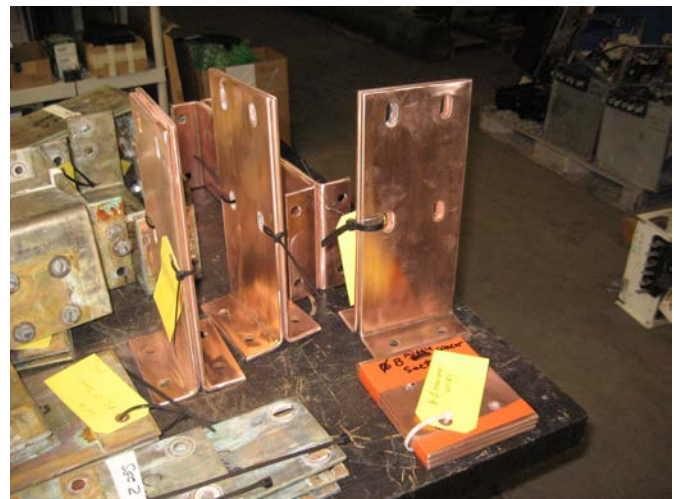
*Just a few of the buss bar pieces as the corrosion from the salt water had to be aggressively removed.*

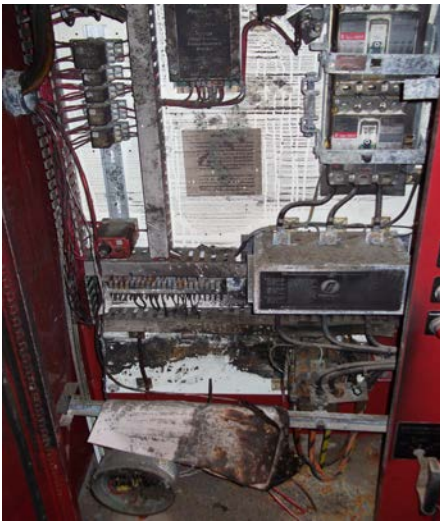
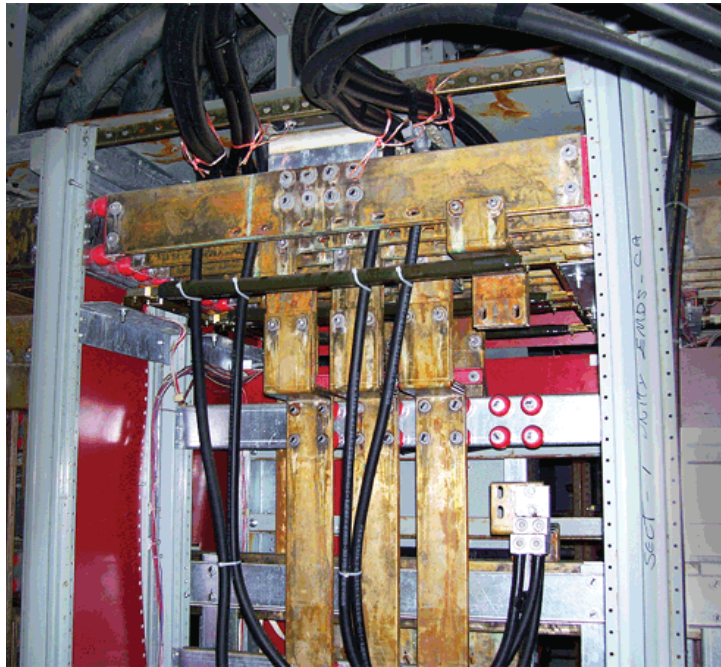
*Even to the untrained eye, this corrosion is easy to spot. Extensive problems are simple to fix: complete replacement. Other situations are tempting to repair, but looks can be deceiving, spending time and money, only to have to come back and replace the unit anyway.*

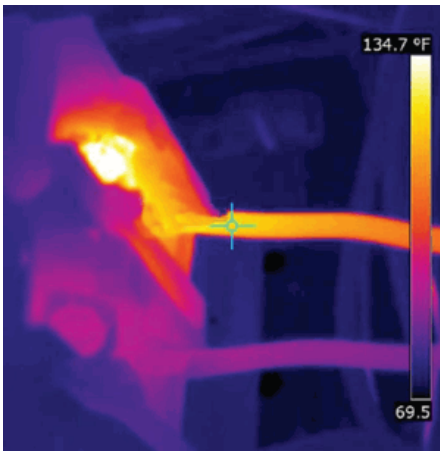
*Just one out of all the various connections can be corroded and start up dangerous overheating.*

corroded wire may not suffice. In some instances an entire section of wire needs to be replaced to ensure all the corroded wire is removed. Even this small amount of corrosion can inhibit electrical conductivity and by doing that will cause the connections and the equipment to heat up. And as we all know, heat is the devil when it comes to electrical apparatus.
