The Longo Response

The Incident

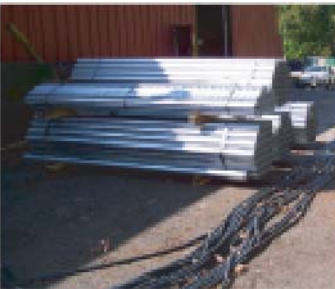
6,000 feet of conduit was needed for the cables to replace main buss running through the building. Obtaining a replacement buss would not have been time effective.

There will be approximately 6,000 feet of new aluminum conduit installed when cable installation is completed.
