The deconstruction of a 125 hp motor and a 4 foot exhaust fan in seconds...

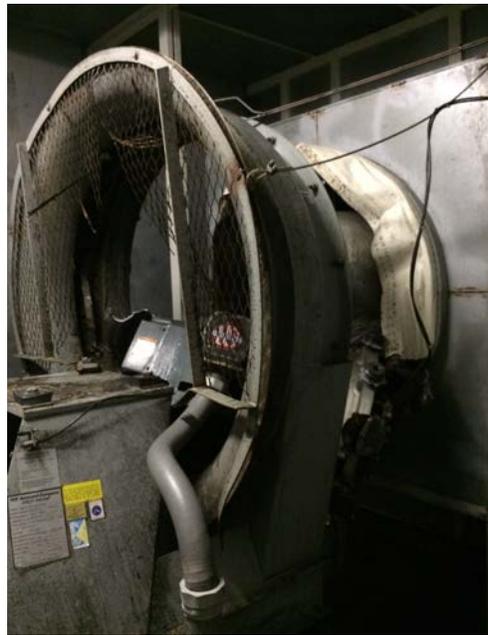
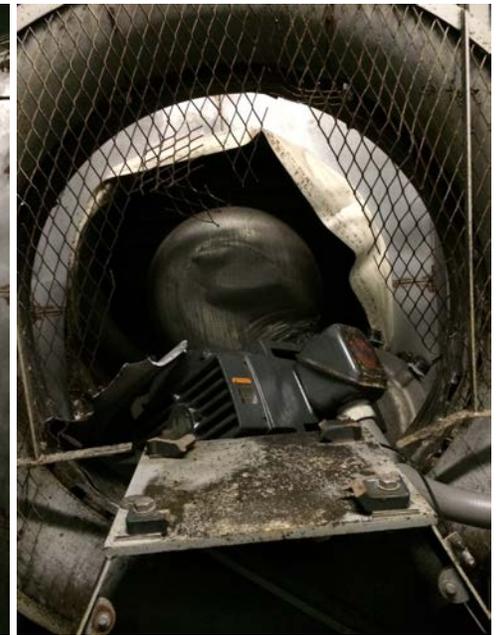
These two photos show the aftermath of the fan that exploded. On the far right you can see where the 1700 lb. motor was torn right off its mountings! Definitely validates stories of fan blades slicing through cinder block walls.

This is the aftermath of a fan that ate itself along with the motor that drove it. The motor is missing in these photos because it was ripped right off its mounting bolts! We have had a few of these over the years, but this one was particularly violent. It was a 48" supply air fan (5500CFM) driven by a 125hp motor controlled by a VFD. Originally the fan was an adjustable blade setup, it was converted and the blades were locked. ONE PROBLEM: All the linkage and bearings were left in place!! It has been in position for almost 20 years.

Fans pick up dust, dirt and other stuff in many ways and it collects on many surfaces of the motor and the fan, most significantly the blades. It would seem logical that a spinning fan would collect this stuff on its blades in a symmetrical pattern. Since we don't live in a logical world all the time, individual blades can pick up their surface crap in a haphazard manner. Add to this any loosening or change in the blade's position or a loose sensor tube, and the imbalance reaches a critical point; then destruction happens quickly. A day or two earlier and this fan may have been humming right along and then the straw moment occurs. In a second, a blade flexes, touches a guard, breaks and the others follow suit in a manic blade jail break.

style. This eliminates potential failure points in the linkage which is the probable cause of this destruction.

This type of problem is sooooo preventable. Regular maintenance and a PM survey will let you know all you need to know about the health of your fan/motor setup. The run to failure concept, that started in the 90's and grew substantially in 2008-2010, may have been seen as a temporary thing. Unfortunately, once the habit of little or no maintenance took hold, it was here to stay. This set of fans had not been tested in 15 years. Regular vibration testing to determine the fans condition is just good insurance. By trending this data we can make an assessment on how quickly the fan's performance is deteriorating.

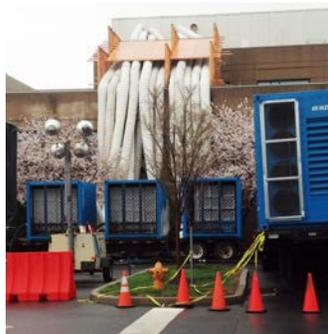
The rental ventilation equipment needed to substitute for the ruined fan and motor.
