August 1997

# THE LONGO LETTER

# ACM Mill and Separator

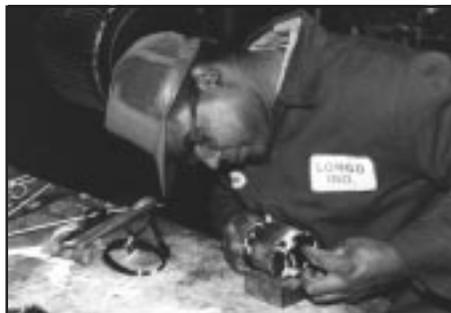
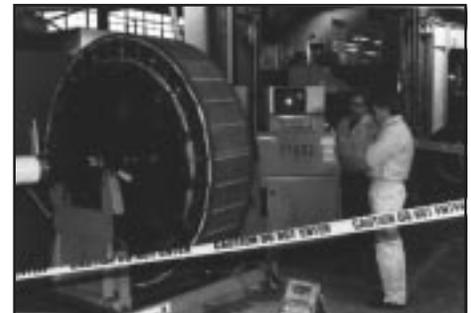
The photos here show a very small motor being rewound and a large rewind synchronous rotor in our balancer (capacity - 20,000 lbs). Small or large, we attend to your job with equal purpose. The rigor of specifications and work plans are custom designed to suit the respective jobs' needs.

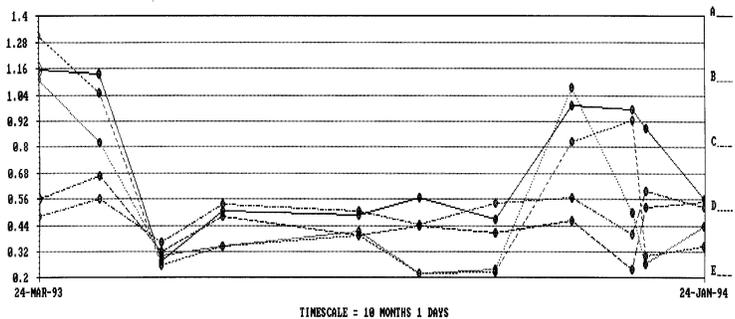
Figure 1. Multiple Trend Plot

Overall levels for the separator initially ranged from 0.47 IPS to 1.31 IPS (Figure 1). Because high vibration levels are expected for a mill, and no baseline data were available, no corrections were made. Overall vibration levels continued to be high the next month, some increasing from 0.47 IPS to 0.55 IPS (see Figure 1).

(A) #4 ACM Mill Sep AA Motor  
 (B) #4 ACM Mill Sep AV Motor  
 (C) #4 ACM Mill Sep AH Motor  
 (D) #4 ACM Mill Sep BV Motor  
 (E) #4 ACM Mill Sep BH Motor

Readings taken the next month fell to the range from 0.25 IPS to 0.35 IPS. The readings were still somewhat high but were classified as acceptable and used as baseline data to begin a history. For the next four months, readings did not exceed 0.56 IPS.

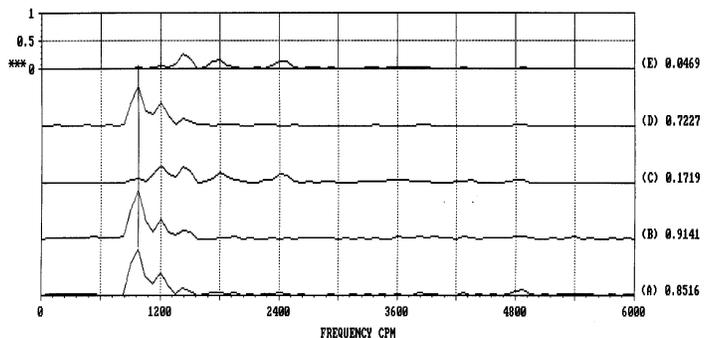
Figure 2. Waterfall Spectral Plot

Then levels increased to the range from 0.45 IPS to 1.07 IPS, similar to the levels recorded initially. And extremely high vibration level (0.9 IPS) was found at the operating speed of the mill, with multiples of operating speed (Figure 2). The recommendation was to inspect the mill and separator for looseness, missing hardware, misalignment, and uneven product buildup on rotating elements. The maintenance department again inspected the separator. Loose bearing housings were causing the shaft to cock, thereby creating misalignment, un-

balance, and looseness. The bearing fits were corrected, a new shaft and new bearings were installed, the unit was descaled and cleaned, and proper belt alignment and belt tension were set. The unit was then returned to service.

Readings the next month ranged from 0.26 IPS to 0.88 IPS; the frequency plots resembled those of prior months. The customer was told that the vibration levels were still too high. We were given a work order to analyze the cause of the persistently high vibration levels.

The investigation of the mill and separator revealed a previously unknown shaft

in the mill that rotated at the same speed as the separator shaft. The bearing fits of the unknown shaft were loose. When the looseness was corrected, vibration levels did not exceed 0.55 IPS.

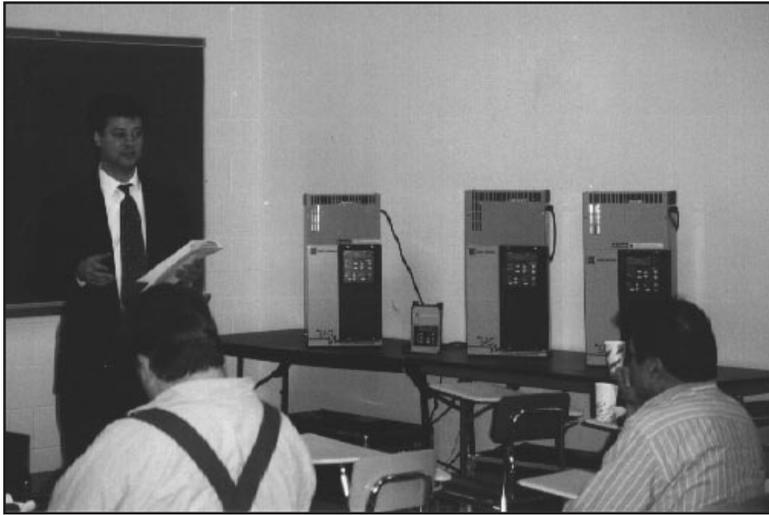
Here, our manager conducts a training session for the customer's people on operation, maintenance and harmonic issues of variable frequency drives (more in next issue). Motors are an integral part of their work.
