August 1997

THE LONGO LETTER

ACM Mill and Separator

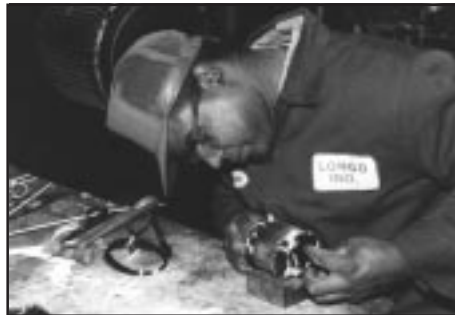
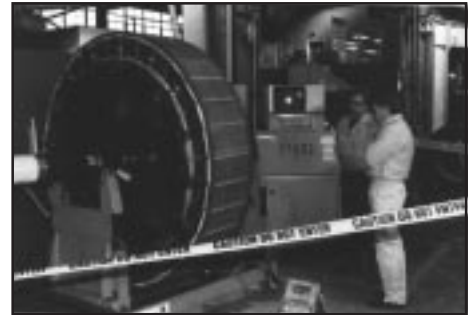
The photos here show a very small motor being rewound and a large rewind synchronous rotor in our balancer (capacity - 20,000 lbs). Small or large, we attend to your job with equal purpose. The rigor of specifications and work plans are custom designed to suit the respective jobs' needs.
