THE LONGO LETTER

June 1998

Rotor Rebuilding

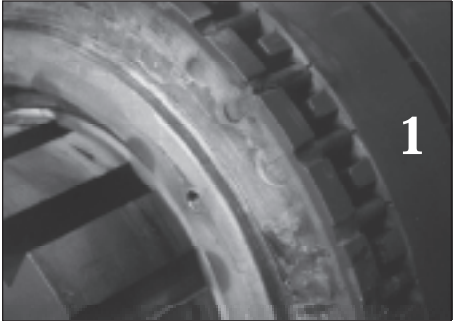
Fabricated rotors which have cracks in them may be rebrazed if the fault is local. This is illustrated in **Photo 1**.

Rebrazing requires controlled conditions to be certain that thermal and mechanical stresses are minimized, and thereafter relieved. Repaired joint integrity must be verified after brazing, using nondestructive techniques such as ultrasonic testing. At best, rebrazing is a “fix”, not a cure. The inherent weaknesses that led to the cracking have not been removed.

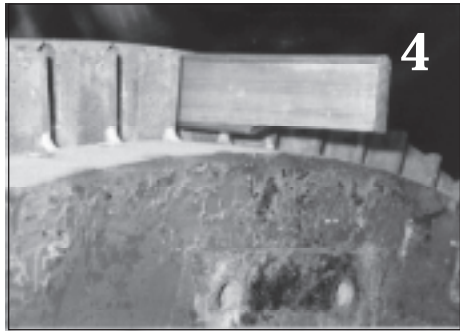
as radiuses at high stress points on the bars, should be built in if the design analysis indicates they are required. A close up of radiusing is depicted in **Photo 4**.

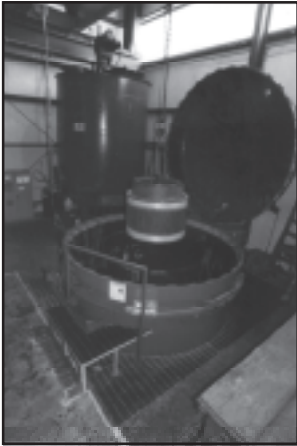
Vacuum Pressure Impregnation
(up to 10 foot diameter)

- Solventless varnish eliminates voids and pockmarked areas created during the curing process of standard solvent-containing varnishes.
- Complete slot fill.
- Elimination of moisture-collecting voids.
- Increased chemical resistance.
- Superior mechanical resistance to winding surges.

- Greater heat dissipation in addition to reducing localized hot spot areas in the motor laminations.
- Superior bond strength while maintaining a flexibility to avoid cracks due to inrush current stress.
- Insulation migration is dramatically reduced.
- Moisture resistant winding integrity.
- Value added to your motor repairs by ensuring long life.
- Effective barrier from carbon tracking.
- Improved efficiency with a cooler running machine.
