When it's time to kick it up a notch...

We were recently awarded the contract to refurbish one of three cooling pumps for a New Haven, CT generating facility. The pump alone was 34 feet in length, weighed 16,000 lbs, and delivered 95,000 gpm of cooling water from the Long Island Sound to the generating plant. The pump had not been serviced for years, so the combination of the long exposure to the salt water, sheer size and coordination of several mechanical services meant organization was as important as our pump expertise. While the project was fairly straight forward—dismantling of the pump housing and motor, the extraction of the pump, rebuilding the pump and

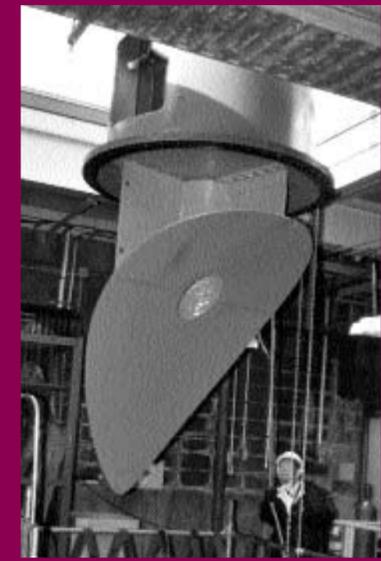
With each part cleaned, repaired, or replaced the reassembly was relatively trouble free. There is always the concern that even these massive elements could go out of round or distort after years of confinement, but that was not the case. Outstanding crane work and a delicate touch had parts easing into place on the first try.

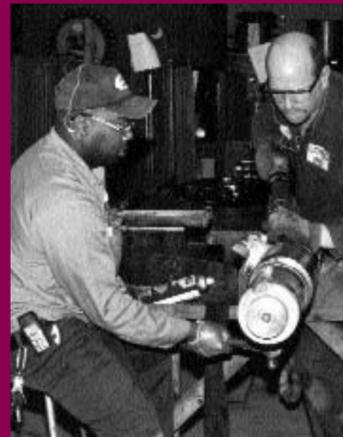
Crouched in the pit, guiding the components together, our Longo team members know exactly when to stop, backup or keep going. The wrong call can have tons of pressure turning seals and bearings into salvage stock!

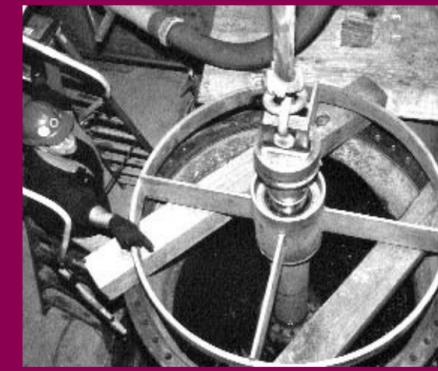
The reconditioned pump was stopped just above the casing rim. It was suspended while the special adapter was removed from the pump shaft so the main shaft from the motor to the pump could be lowered into position.
