# When it's time to kick it up a notch...

We were recently awarded the contract to refurbish one of three cooling pumps for a New Haven, CT generating facility. The pump alone was 34 feet in length, weighed 16,000 lbs, and delivered 95,000 gpm of cooling water from the Long Island Sound to the generating plant. The pump had not been serviced for years, so the combination of the long exposure to the salt water, sheer size and coordination of several mechanical services meant organization was as important as our pump expertise. While the project was fairly straight forward—dismantling of the pump housing and motor, the extraction of the pump, rebuilding the pump and

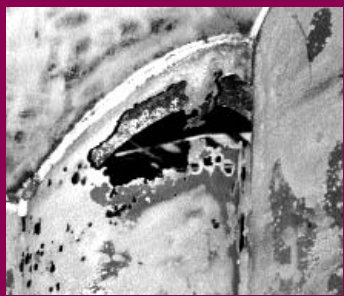
Barnacles, clams and an assortment of sea life had made a home on all the submerged components.

Corrosion on the diverter was substantial, eating completely through the column support areas of the diverter. New sections were welded into place, welds cleaned and smoothed before the unit received its bright protective coating.

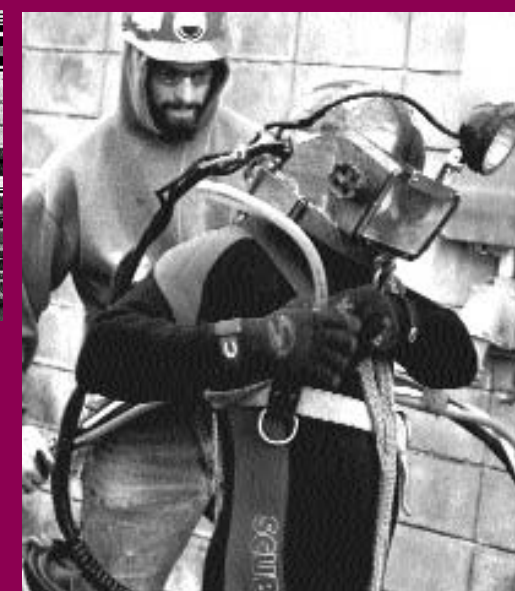
Divers were critical for the extraction, positioning and aligning the jack beneath the pump, adding the needed pressure to break the pump loose from the encrusted casing.

The 20 ton crane alone was simply not enough to ensure the pump would move. With this in mind, a dive team was on hand to add jack pressure to the bottom of the submersed pump. Working in murky water with about one foot visibility, the dive team and crane operator were choreographed by our Longo crew to dislodge the pump from the grip of the assorted tiny crustations that had been cemented to the pump and the walls of the casing. With the crane operator calling out readings as he approached the limit of his machine and crackling speaker voice of the diver as he described reaching the limit of his jack, nothing was moving! Then slowly, and literally an inch at a time, the pump shaft began to rise up.

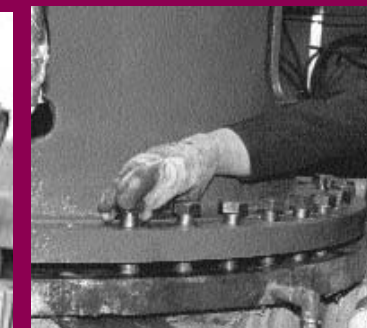
With each part cleaned, repaired, or replaced the reassembly was relatively trouble free. There is always the concern that even these massive elements could go out of round or distort after years of confinement, but that was not the case. Outstanding crane work and a delicate touch had parts easing into place on the first try.

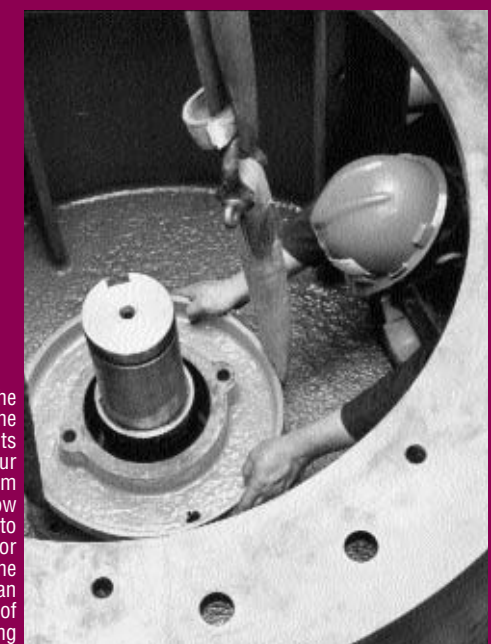
Crouched in the pit, guiding the components together, our Longo team members know exactly when to stop, backup or keep going. The wrong call can have tons of pressure turning seals and bearings into salvage stock!

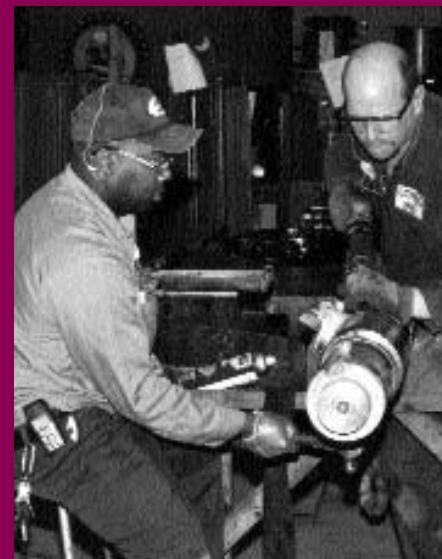
The main shaft of the pump was examined, worn protective sleeves removed and the shaft was checked for balance and straightness.

One day in the shop and the pump was apart and work underway to repair it. New components had been ordered and were already in house. Most of the damaged areas were expected, but, as always, there were a few surprises and we consulted with our customer to decide what to repair and what to replace. With Longo's extensive in house mechanical capabilities, (machining, welding, balancing super-sized components) we are often able to salvage components rather than just order new. Even when "money is no object" it is often time that becomes the critical factor and Longo is uniquely geared to cheat the clock. The main shaft was cleaned and when checked against the specs found to have a slight bend. A plating contractor on stand-by was notified and the shaft built up, turned, and, ground to bring it

back in line with the specifications. Longo's resources both inhouse and outside came into play to resolve this one problem.

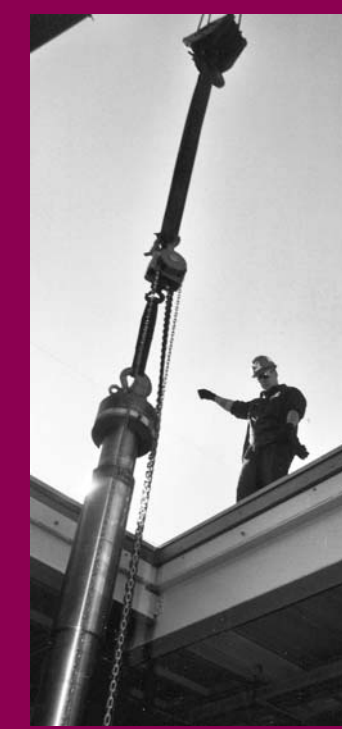
The reconditioned pump was stopped just above the casing rim. It was suspended while the special adapter was removed from the pump shaft so the main shaft from the motor to the pump could be lowered into position.

The reinstallation of the motor/pump unit was the reverse of the extraction, step by step with proper caution. Even though all the components were either new or resurfaced one can never assume anything when dealing with tons of weight and tight tolerances. The Longo crew paid specific attention when lining up couplings and seals. Even a slight misalignment under these forces could result in a pile of useless scrap metal. With everything back in place the unit was started up and, to no surprise for us, it purred!
