# The deconstruction of a 125 hp motor and a 4 foot exhaust fan in seconds...

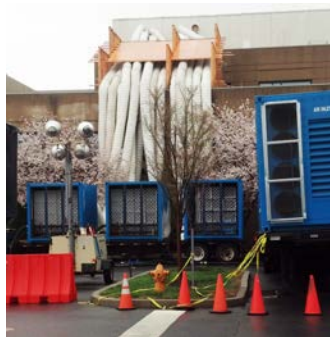
*The rental ventilation equipment needed to substitute for the ruined fan and motor.*
