All balled up!

A huge 1000 HP, 240 RPM, 2300 Volt ball mill motor, with a rotor over 7 feet in diameter, survived for a long time in the harsh confines of a milling operation until a small unforeseen chain of events took over.

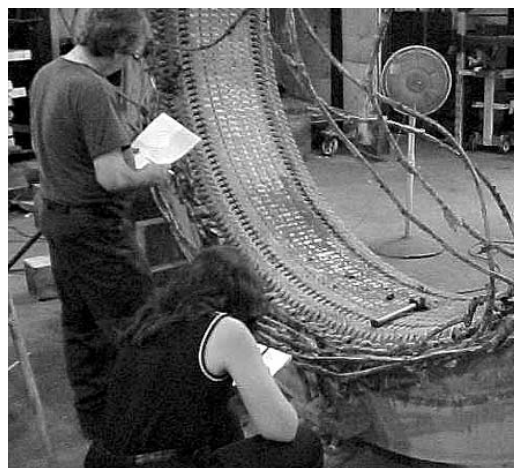
Winding group leader and engineer determining connections of stator winding.

any damage not visible at first sight. We hate surprises as much as our customers do. The winding connections, along with the insulated surge retainer ring, were quickly cut away to gain access to the slot wedges and windings. The combination of age and dust had the wedges and windings held very tight, so the 9 ton stator was promptly moved to the power cleaning booth. Our 15,000 psi water blaster removed the accumulated dust, residue and wedges; then the stubborn windings could readily be removed.

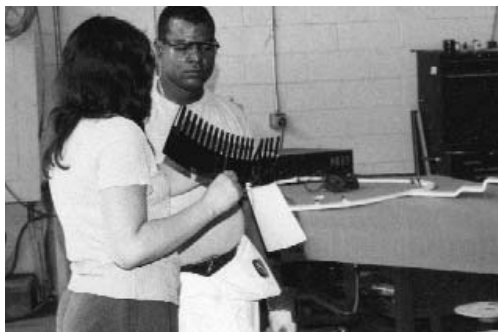
Lamination disassembly nearly complete.

After the winding removal, the disassembly of the damaged stator laminations begins.

When the laminations were examined it was discovered there were four different segment patterns dictated by the geometry of the frame and the slot arrangement. While this may be unconventional, there was not time to consider a different design pattern, so the exact duplicates

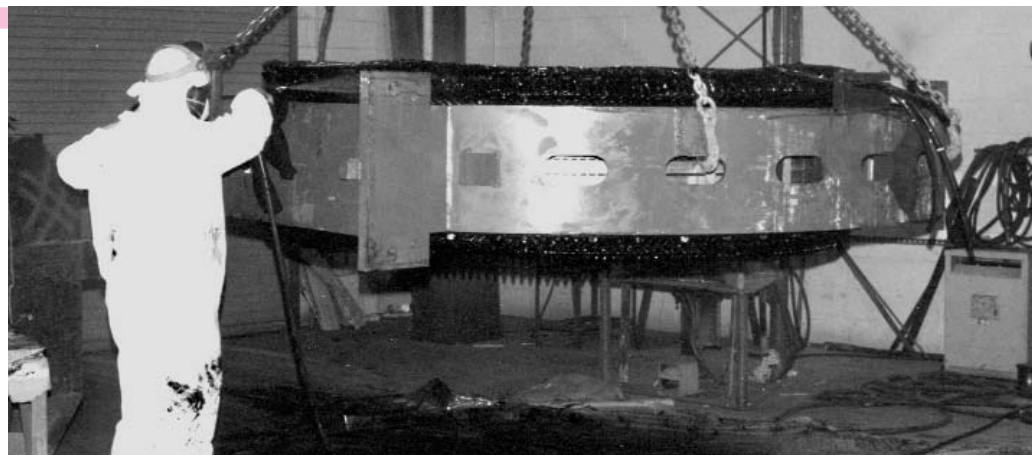
Abrasive-resistant spray being applied.

Since this motor was going back into that dusty and grimy environment, we recommended additional protection for the windings. An abrasive-resistant coating was applied over the windings, building up a protective shield that is resilient against the impinging dust particles. Without the coating, the windings would not last anywhere near as long. **Another Longo Advantage of thinking ahead and not just merely doing the essentials.**

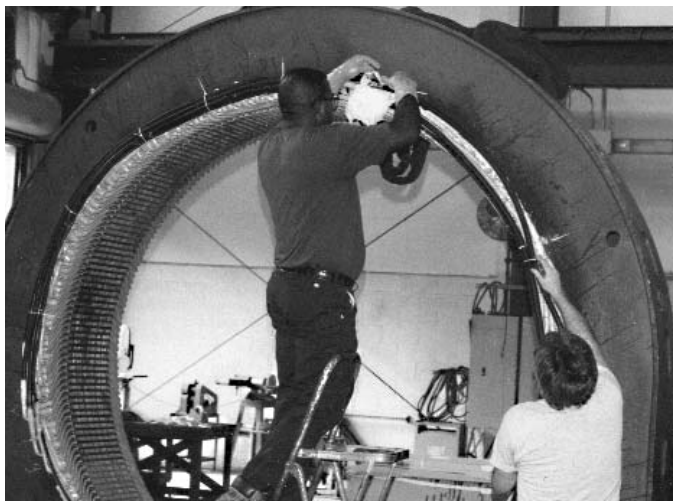
Relamination completed, new windings installed, the motor leads are installed.

Once in-house, the rebuilding of the stator could get underway. With the stator laying on its side, two men were able to comfortably walk around the inside of it installing the laminations. Individual centering posts, trapezoidal in shape, held each one in place. There were twelve 30 degree, 22 inch long segments per layer. They were stacked in multiple layers with cooling ducts in between. A total of 5200 individual lamination pieces were needed to complete this job.

The preformed windings were securely fit into place and then locked in with new fiberglass

wedges and spacer bars. The windings were supported with packing between each coil and laced together with wrapping material. Our proprietary coil bracing system was employed to forestall coil movement on startup and while running. The full load torque is 21,875 pound feet, which translates into a force of 6100 pounds on the coils.

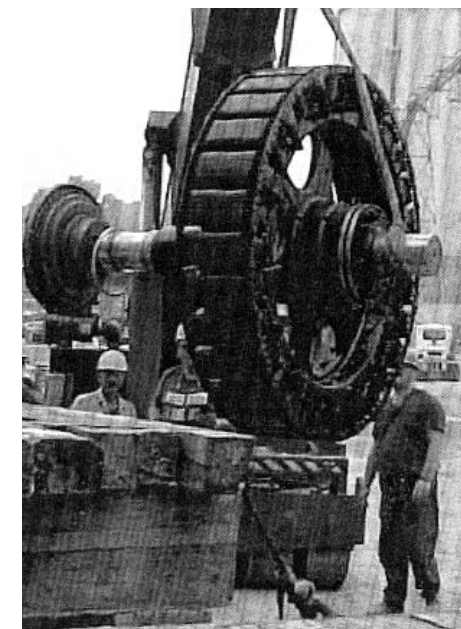
Rotor rigged at job site.

performed to be certain the units were correctly remanufactured. When the motor was reinstalled and the rotor was placed into its pedestals, alignment problems were discovered. Longo's state-of-the-art techniques, like laser alignment, were not viable in this situation. Using old fashioned dial indicators and feeler gauges we were able to define these issues. With the customer's able support this was resolved and the unit prepared for startup. **Another Longo Advantage of defining issues and sticking with a job until it is done right.**
