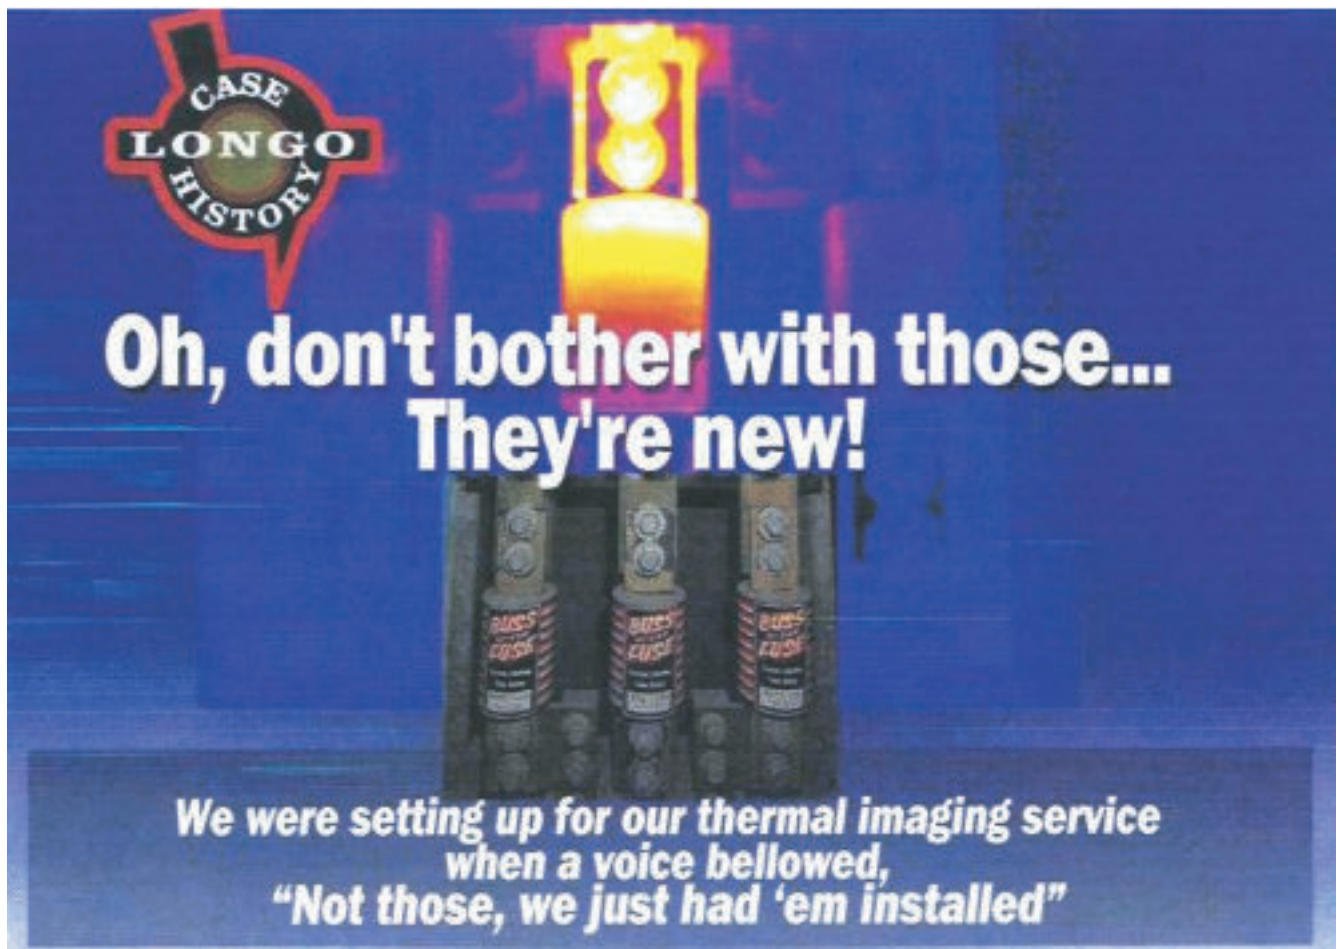
With the words, "not those..." ringing in his ear the thermographer had already begun to scan the unit. "If this is a new unit, you have a new problem," the tech called out as the thermal imaging was picking up sure signs of a malfunction in this brand new unit. The imaging had located a thermal anomaly in a fuse clip.

Electrical distribution system failures are among the most prevalent types of equipment breakdown losses. Such failures are often the result of loose wiring, dirt or moisture in connections and other parts. This can result in electrical arcing, overheating or even fire. This case illustrates when it comes to electrical components, new or old, it is important to inspect them on a regular basis.
