When it's time to kick it up a notch...

We were recently awarded the contract to refurbish one of three cooling pumps for a New Haven, CT generating facility. The pump alone was 34 feet in length, weighed 16,000 lbs, and delivered 95,000 gpm of cooling water from the Long Island Sound to the generating plant. The pump had not been serviced for years, so the combination of the long exposure to the salt water, sheer size and coordination of several mechanical services meant organization was as important as our pump expertise. While the project was fairly straight forward—dismantling of the pump housing and motor, the extraction of the pump, rebuilding the pump and

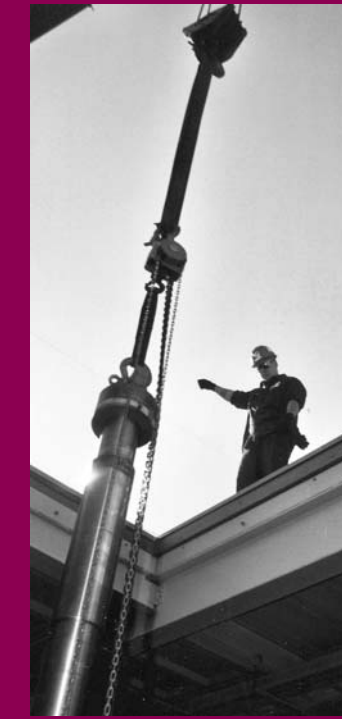
The main shaft of the pump was examined, worn protective sleeves removed and the shaft was checked for balance and straightness.

One day in the shop and the pump was apart and work underway to repair it. New components had been ordered and were already in house. Most of the damaged areas were expected, but, as always, there were a few surprises and we consulted with our customer to decide what to repair and what to replace. With Longo's extensive in house mechanical capabilities, (machining, welding, balancing super-sized components) we are often able to salvage components rather than just order new. Even when "money is no object" it is often time that becomes the critical factor and Longo is uniquely geared to cheat the clock. The main shaft was cleaned and when checked against the specs found to have a slight bend. A plating contractor on stand-by was notified and the shaft built up, turned, and, ground to bring it

back in line with the specifications. Longo's resources both inhouse and outside came into play to resolve this one problem.
