The Longo Response

The Incident

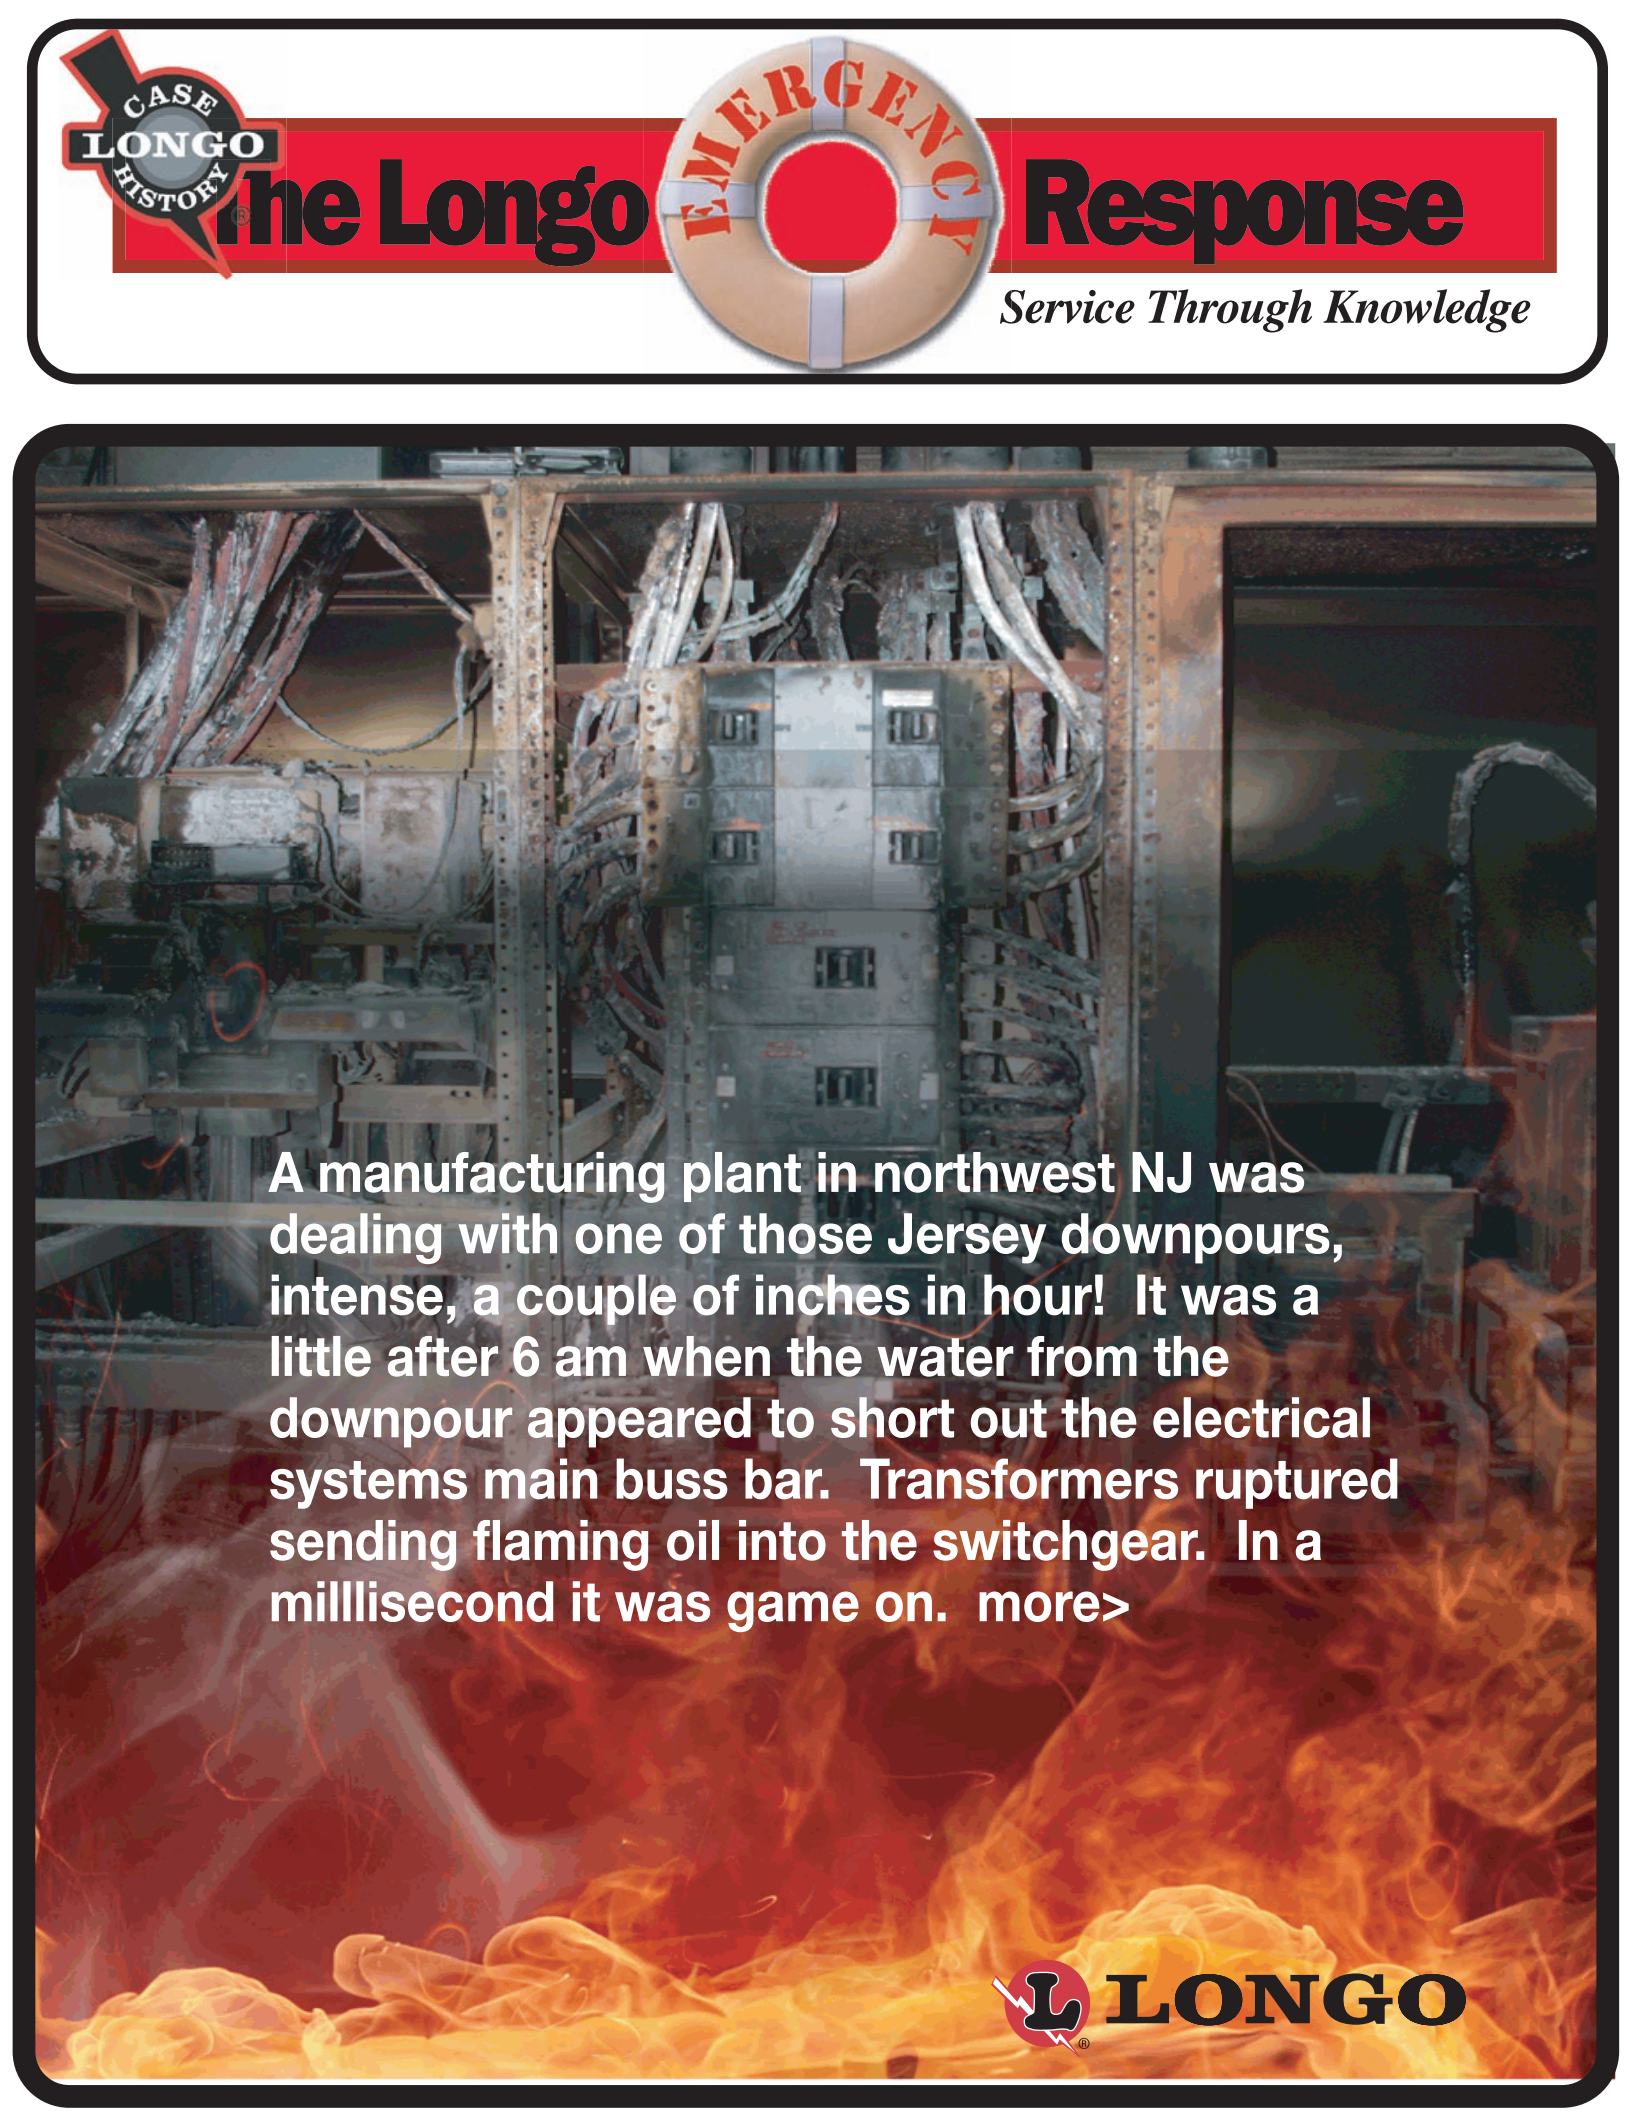
A manufacturing plant in northwest NJ was dealing with one of those Jersey downpours, intense, a couple of inches in hour! It was a little after 6 am when the water from the downpour appeared to short out the electrical systems main buss bar. Transformers ruptured sending flaming oil into the switchgear. In a millisecond it was game on. [more>](#)
