THE LONGO LETTER

September 1999

Transformer Replacement 7000 KVA 69,000/5000 V ... a turnkey job for **LONGO**

Maintaining Motor Efficiency During the Rewind Process

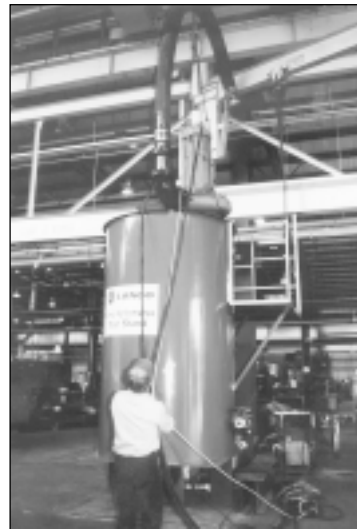
Pump performance testing & documentation . . . an integral part of a quality rebuild.

Fairbanks-Morse, another flagship name, has appointed Longo as an Authorized Fairbanks-Morse Submersible Motor Repair Facility for the Metropolitan New York and New Jersey areas. This is most timely, since we now have in-house capability to load test these pumps to verify their performance and print a curve to assure users of the performance. *We have taken the lead again!*

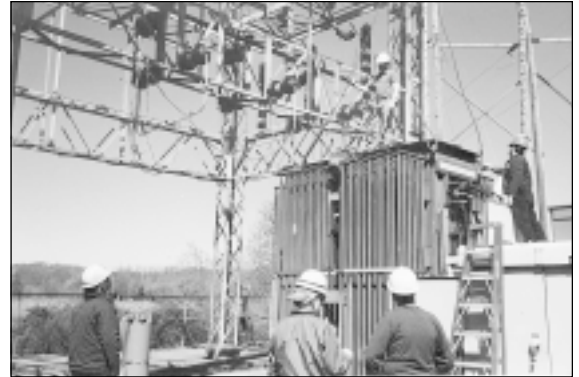
Old unit being staged for removal

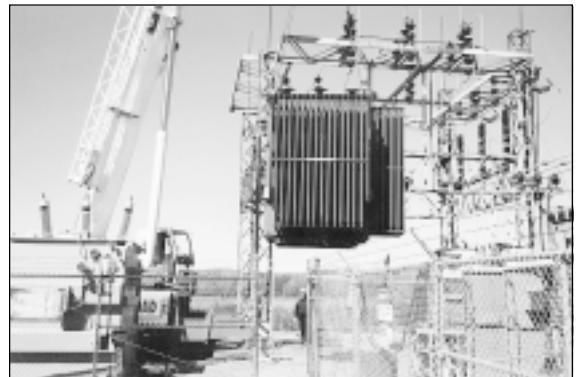
Old unit being removed

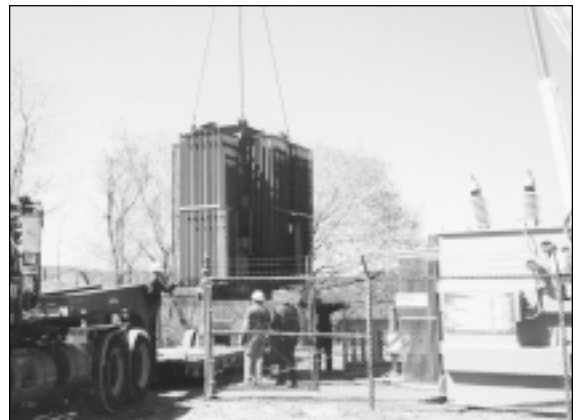
Loading old unit

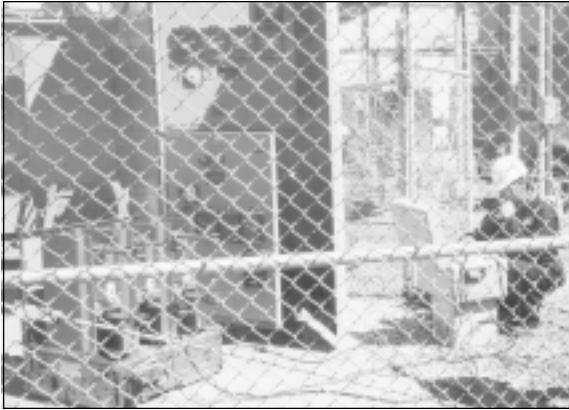
Testing the breaker

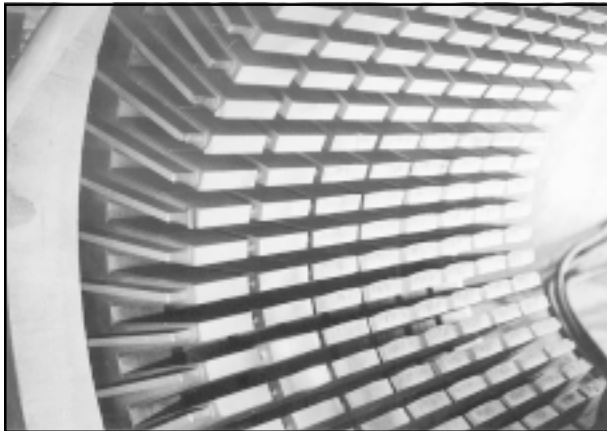
The value of a core test is evident in the accompanying photograph, taken during an actual core test. The area with the bright glow had no physical evidence of a fault when viewed with the naked eye. Our goals in rewinding include maintaining efficiency, improving it where possible, and increasing reliability of the motor as a whole.

We use quality controls that can prevent, or, at least identify, core degradation. Our ovens have tight temperature control set at the minimum temperature needed to pyrolyze a winding. Core quality is measured prior to and following winding removal by means of a core loss test. This test magnetizes the core to a specific value, then measurements are made of the core temperature and watts loss. Core quality and core loss are maintained if the temperature and wattage are the same before and after pyrolyzing. The pass-fail criteria for these core tests was developed by our engineers, from statistical analysis of over 1000 core tests performed in Longo facilities.
