A PUMP IS LIKE A BOX OF CHOCOLATES...

Once again the Longo shop in Wharton prepared for the arrival of another major pump assignment. This one came in the form of a 10+ ton, 68,500 GPM, 25ft long cooling pump with 5 foot intake and 4 foot discharge driven by a 2,100 HP motor. The pump was brought in for a refurbishing due to a wobbling shaft. The pump was picked up from its Northern New Jersey location and was in our Wharton Servicenter on Tuesday afternoon, October 25, and originally due back at the customer's site on November 2, essentially a 7 day turnaround.

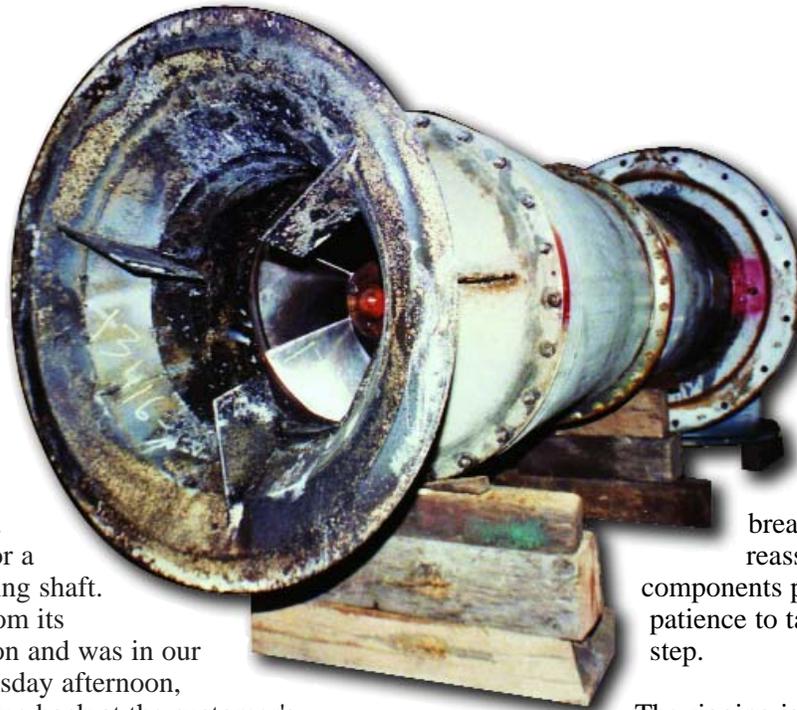
Weighing over 10 tons the pump was supported below by a series of 12"x 12" timbers and from above by slings from our 25 ton crane. Obviously safety for the crew is paramount, and properly securing the pump is

essential to prevent movement as the components are removed.

The rigging is set in anticipation of the removal sequence and the proper sequence is vital. When the parts are separated they tend to have a life of their own. As the pressure of the bolts is released they want to tilt, rotate and move. Jumping in and just removing any and all bolts without regard to the dynamics involved can not only be unsafe, but cause damage to interior components such as shafts, sleeves and bearings. It doesn't take much movement from a loose section to make an expensive mistake.

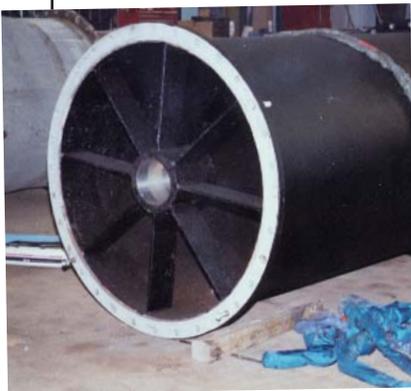
Left: The magnesium anode is probably one of the most "low tech" solutions to corrosion still in use today.

We discovered the line shaft bearing journal was under sized. The other potential problem was the 1 1/2 ton impeller which we anticipated would have to be dynamically balanced, and it in fact did need it. Line shaft sleeves and the lower casing bearing bore were repaired. New magnesium anodes were to be installed along with a host of bearings, The six 15 pound sacrificial anodes are designed to draw the galvanic action inside the pump column thereby protecting the actual carbon steel components. The electrolytic action from the water and the metals will erode the anode sparing the steel casing. This is simple inexpensive protection, but not for the life of the pump. It will be a service item each time the pump is worked on.

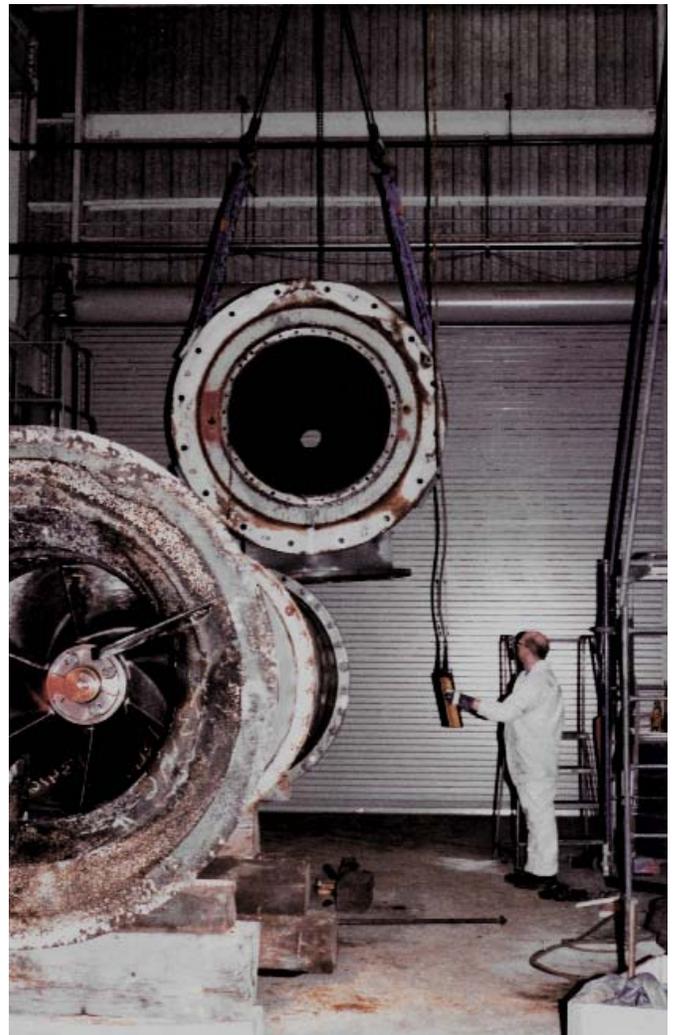
Above: You see the size of the pump and its sections. The right equipment, a 25 ton crane, and correct rigging makes the disassembly of the giant pump seem like childs play..

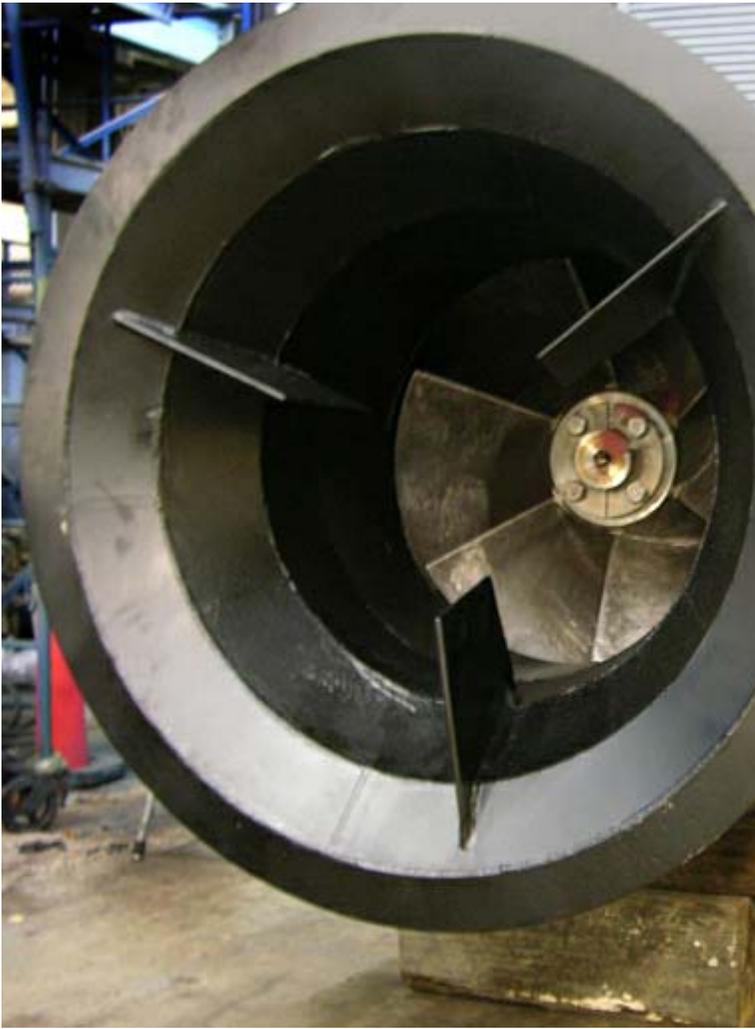
The finished pump is ready to be loaded onto the Longo flat bed and delivered to the cusomter. The final turn around time was actually 13 days which included unexpected time for re-machining the bore of the center casing.
