A PUMP IS LIKE A BOX OF CHOCOLATES...

Once again the Longo shop in Wharton prepared for the arrival of another major pump assignment. This one came in the form of a 10+ ton, 68,500 GPM, 25ft long cooling pump with 5 foot intake and 4 foot discharge driven by a 2,100 HP motor. The pump was brought in for a refurbishing due to a wobbling shaft. The pump was picked up from its Northern New Jersey location and was in our Wharton Servicenter on Tuesday afternoon, October 25, and originally due back at the customer's site on November 2, essentially a 7 day turnaround.

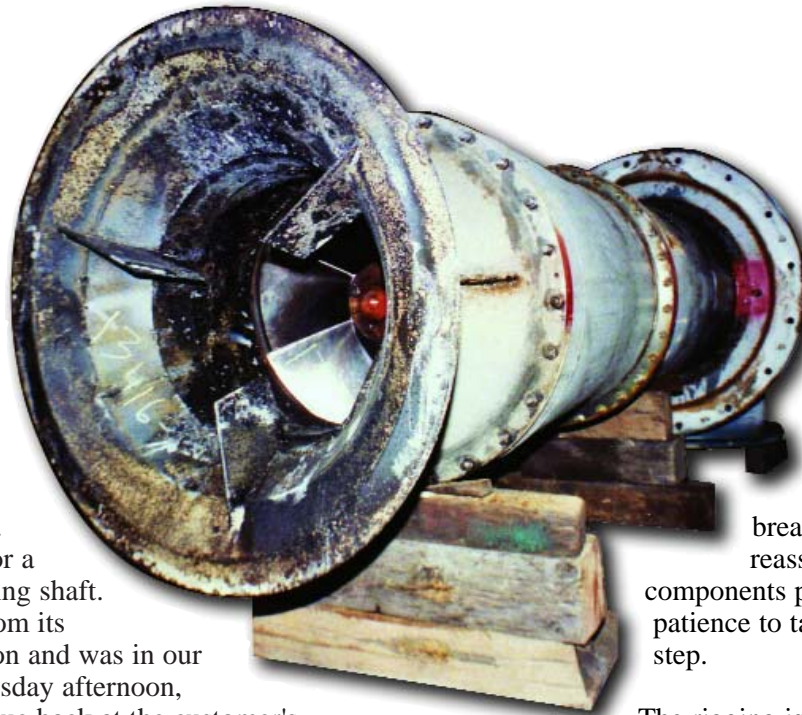
Weighing over 10 tons the pump was supported below by a series of 12"x 12" timbers and from above by slings from our 25 ton crane. Obviously safety for the crew is paramount, and properly securing the pump is

essential to prevent movement as the components are removed.

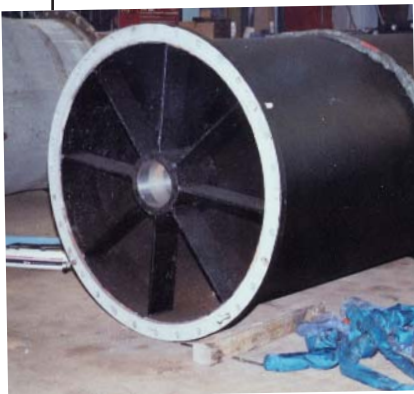
Left: The magnesium anode is probably one of the most "low tech" solutions to corrosion still in use today.

We discovered the line shaft bearing journal was under sized. The other potential problem was the 1 1/2 ton impeller which we anticipated would have to be dynamically balanced, and it in fact did need it. Line shaft sleeves and the lower casing bearing bore were repaired. New magnesium anodes were to be installed along with a host of bearings, The six 15 pound sacrificial anodes are designed to draw the galvanic action inside the pump column thereby protecting the actual carbon steel components. The electrolytic action from the water and the metals will erode the anode sparing the steel casing. This is simple inexpensive protection, but not for the life of the pump. It will be a service item each time the pump is worked on.

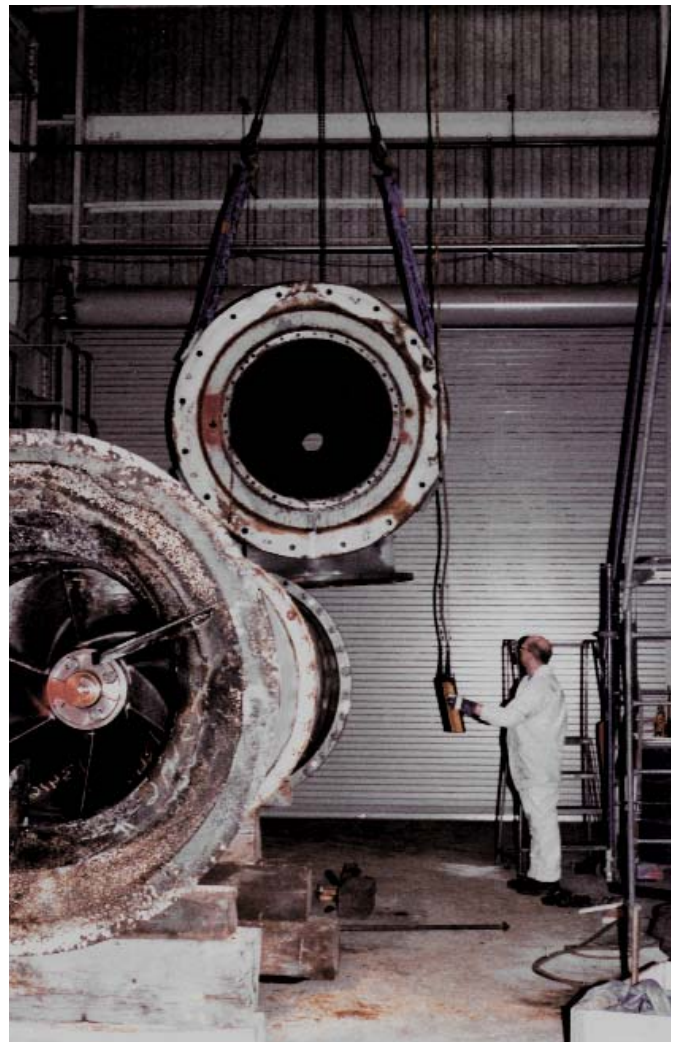
Above: You see the size of the pump and its sections. The right equipment, a 25 ton crane, and correct rigging makes the disassembly of the giant pump seem like childs play..

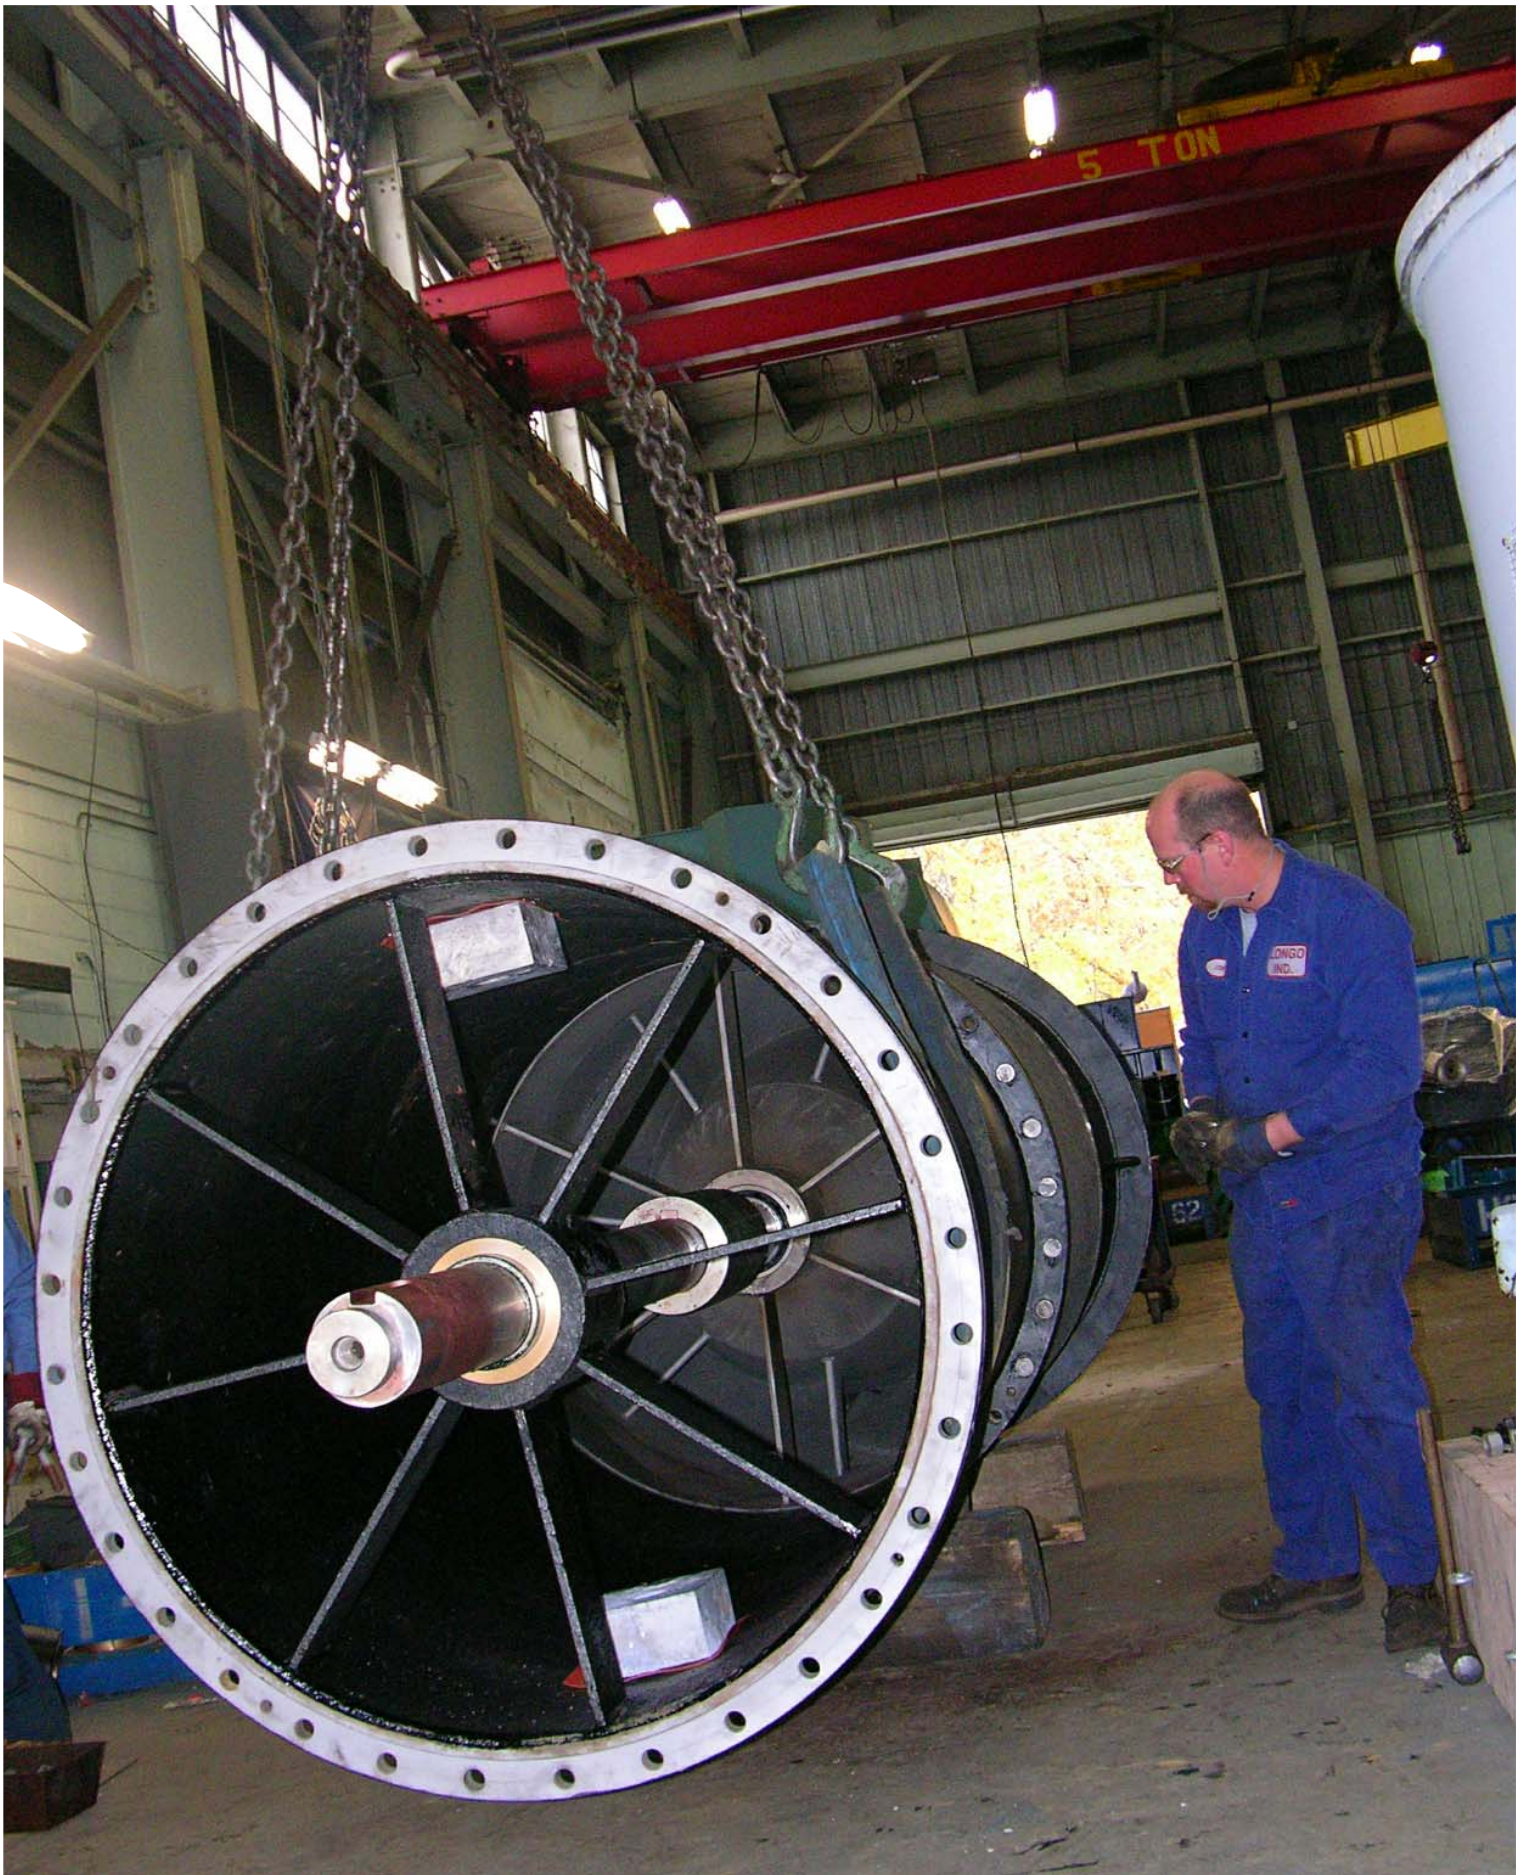
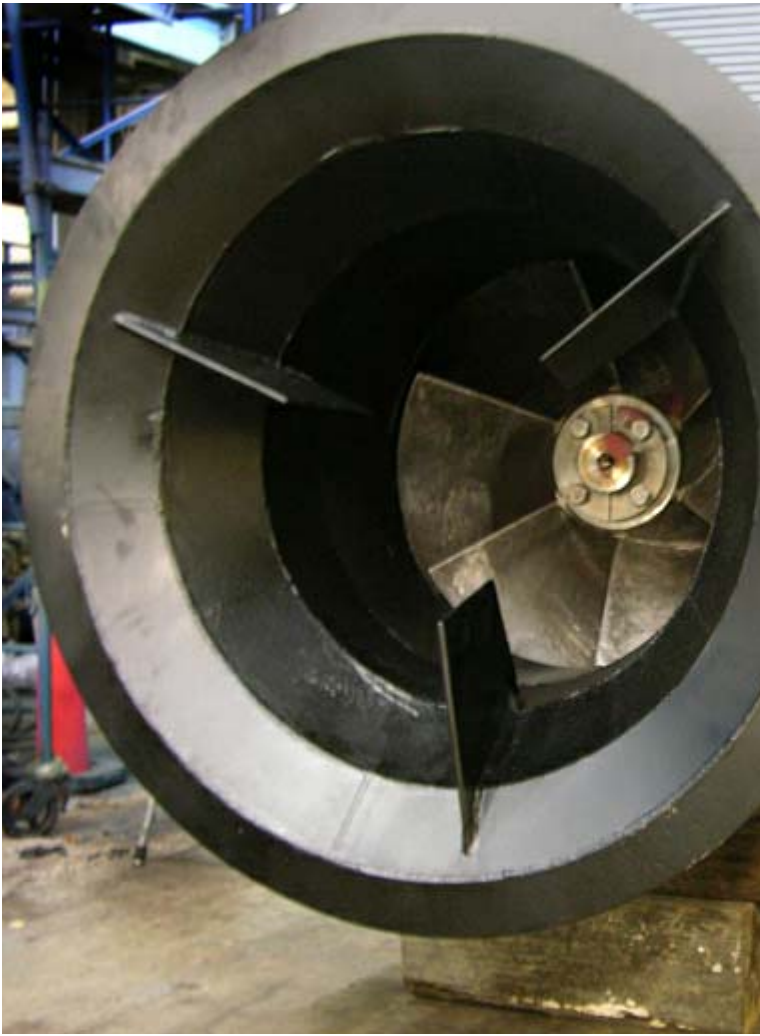
The finished pump is ready to be loaded onto the Longo flat bed and delivered to the cusomter. The final turn around time was actually 13 days which included unexpected time for re-machining the bore of the center casing.
