A view from the top...

On-site work is always a challenge, whether repairing switchgear in a stifling hot cubicle, replacing a pump up to your knees in some vile liquid concoction or motor work out in the elements. Recently, at the end of November, Longo was on site rebuilding two 1750 Hp, 4000 KV ID Fan motors for a major power company. The motors were located outside on the 12th floor of the power station just outside of Philadelphia. As you can see, the view was great, but the working conditions outside on the top floor of the building were less than ideal. Due to the required turnaround, our team was up there **24/7, night and day, bright sun and cold dark nights, for 13 days.**

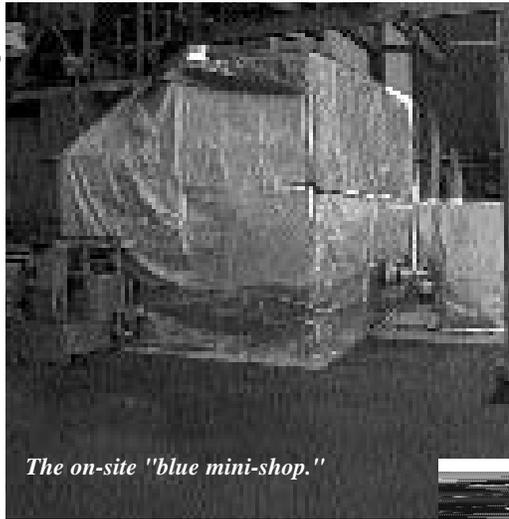
The on-site "blue mini-shop."

On this job, we had to strip, clean and wind the stator in place which meant building a "mini shop" on site. Once wound, the stator had to be heated to cure the new windings and the mini shop became a propane powered mini oven. In the shop, rewinds are completed by immersion in our VPI tank to completely saturate the windings and ties under pressure, forcing the protective epoxy deep into every spot of the winding. This is vital to protect the windings from the tremendous torque of these motors. Since there was no VPI tank on-site, plans had to be made from the very start of the project to utilize an alternative method to achieve the same results.

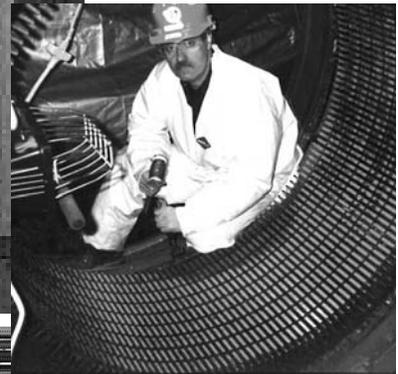
It takes discipline, superior technical skills and the confidence to know they are some of the best in the business.
